HOWARD COUNTY HISTORIC PRESERVATION COMMISSION

June Agenda

Thursday, June 2, 2016; 7:00 p.m.

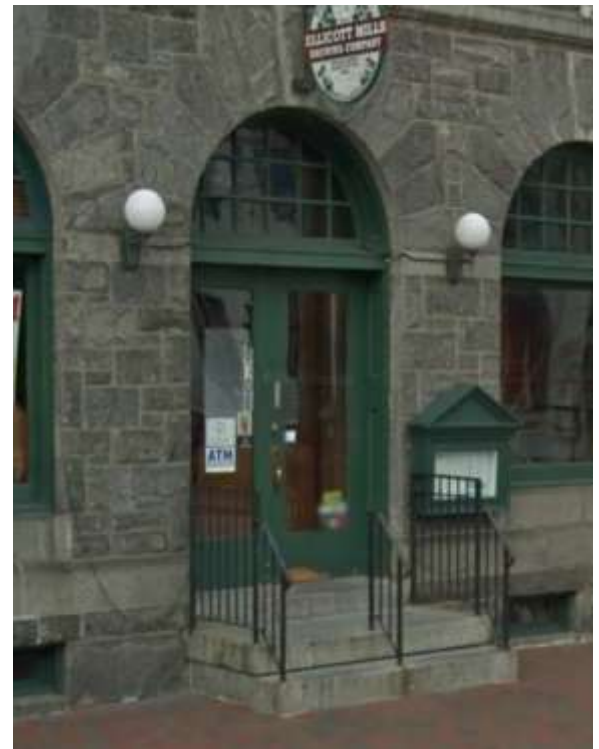
Figure 1 - Front steps

Background & Scope of Work: According to SDAT the building dates to 1920, but the Guidelines date the building to 1905. This building is located in the Ellicott City Historic District. The Applicant proposes to add a 22-inch deep by 7-inch high and 86.5-inch wide piece of granite on top of the existing top step leading into the building in order to create a deeper sill. The Applicant seeks Façade Improvement Program funds for the work. The Department of Inspections, Licenses and Permits has required the Applicant to change the swing of the doors in order to comply with the fire code. The doors need to swing out on to the street, instead of swinging in to the building. As a result, there needs to be a deeper sill or landing when the doors swing out to the street, instead of the current step down. The added granite will extend the landing out of the door, but not completely cover the top step, so that there is still a proper rise and run down to the bottom step.

Staff Comments: Chapter 6.C of the Guidelines states, “granite, a common building material in Ellicott City in the 18th and 19th centuries, is one of the most distinguishing characteristics of the historic district. Used most commonly on buildings constructed between 1800 and 1840, its use continued into the 20th century as seen...in the façade of the Talbot’s Lumber Company building (1905).” The addition of the step is required in order to comply with the fire code. However, the proposed granite step will match the existing granite steps and blend in with the building, which complies with Chapter 6.C recommendations, “maintain or restore original brick, stone, concrete block or stucco. Make repairs with materials that match the original as closely as possible” and “if a masonry feature must be replaced, use material as similar to the original as possible, particularly if the materials are visible from a public road or are key elements of the building’s style or character.” Staff finds this guideline applies even though the step is being added and not replaced. The new step will be granite to match the existing steps.

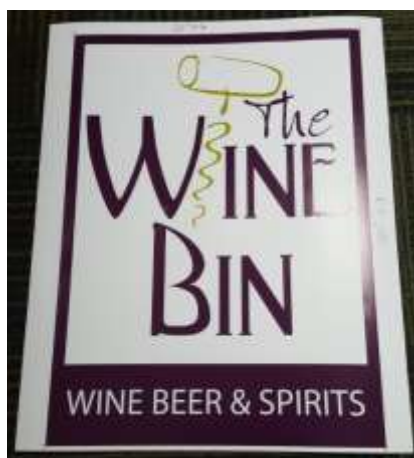
Figure 2 - Proposed sign

Background & Scope of Work: According to the Historic Sites Inventory form the building dates to 1938-1939. This building is located in the Ellicott City Historic District. The Applicant proposes to replace the signs on the building with news signs that will be the same dimension, color scheme and material. The signs will be located in the existing locations at both sides of the building. The signs will be 5 feet high by 3 feet wide for a total of 15 square feet. The sign will read:

There will be a comma between 'wine' and 'beer'; there was a small typo in the proof.

Staff Comments: The existing signs were approved by the Commission in 2008, but have been altered slightly over time to include 'beer' at the bottom. The new proposed signs will be the same as the existing, but have a small tag line at the bottom indicating the other products sold at the store. The sign complies with Chapter 11.A recommendations, "use simple, legible words and graphics" and "use a minimum number of colors, generally no more than three. Coordinate sign colors with the colors used in the building façade." The sign will only have three colors and they are the same as the previously approved colors, which directly coordinate with the colors on the front of the building. Chapter 11.A

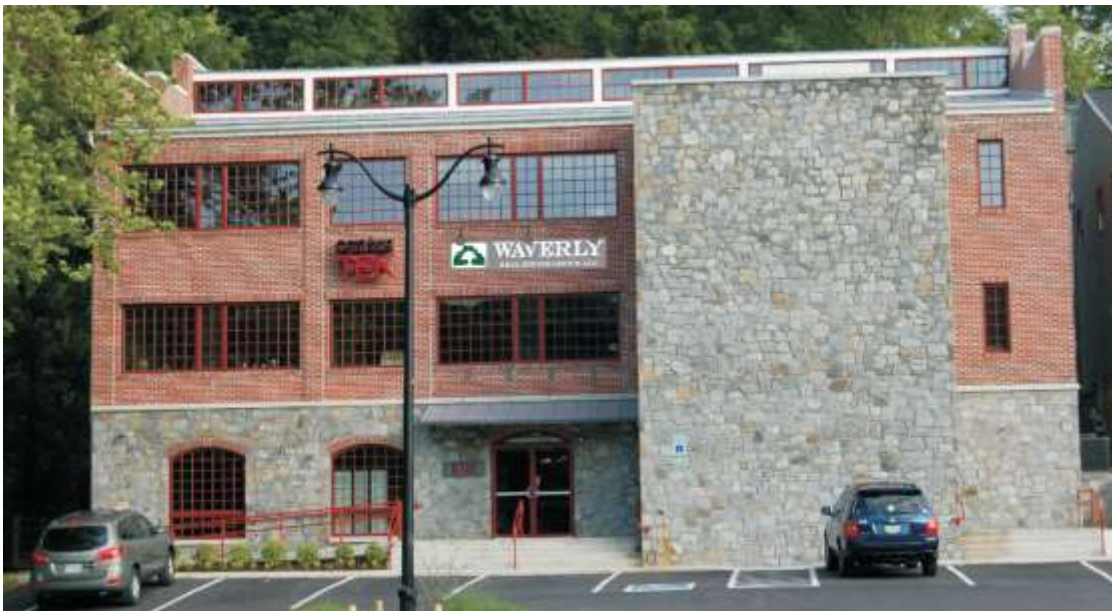
Figure 3 - Current proposal for approval

Background & Scope of Work: This property is located in the Ellicott City Historic District. According to SDAT the building dates to 2008. The property owner came before the Commission in April and May 2016 for approval to install various styles of sign. The Applicant requested the case be continued to the June meeting to obtain flat panel mock-ups from his sign maker. The new proposal for the Waverly sign will be 113 inches wide by 25 inches high, for a total of 23 square feet. The sign is shown below:

The Applicant and Commission agreed to continue the meeting after the Applicant mentioned another business would be installing a sign in the future. The current proposal is for flat mounted signs on the brick between the second and third floor windows, as shown above, with lighting provided by three gooseneck lights. The gooseneck lights comply with Chapter 11.A recommendations, “use indirect lighting or concealed light fixtures with concealed wiring to illuminate signs. If the light source will be visible, select a fixture compatible with the style of the building. Minimize glare by focusing the light on the sign.” The location of the flat mounted panels on the brick complies with Chapter 11.B recommendations, “Incorporate the sign into the façade of the building. Signs should fit within the lines and panels of the façade as defined by the building frame and architectural details.” There will be additional flat mounted signs on the building once the other businesses apply for them. These signs would also be located in the brick area, which complies with Chapter 11.B recommendations, “if there is more than one flat-mounted sign on a building façade, coordinate their locations. For example, signs may be placed in the same horizontal plane.”

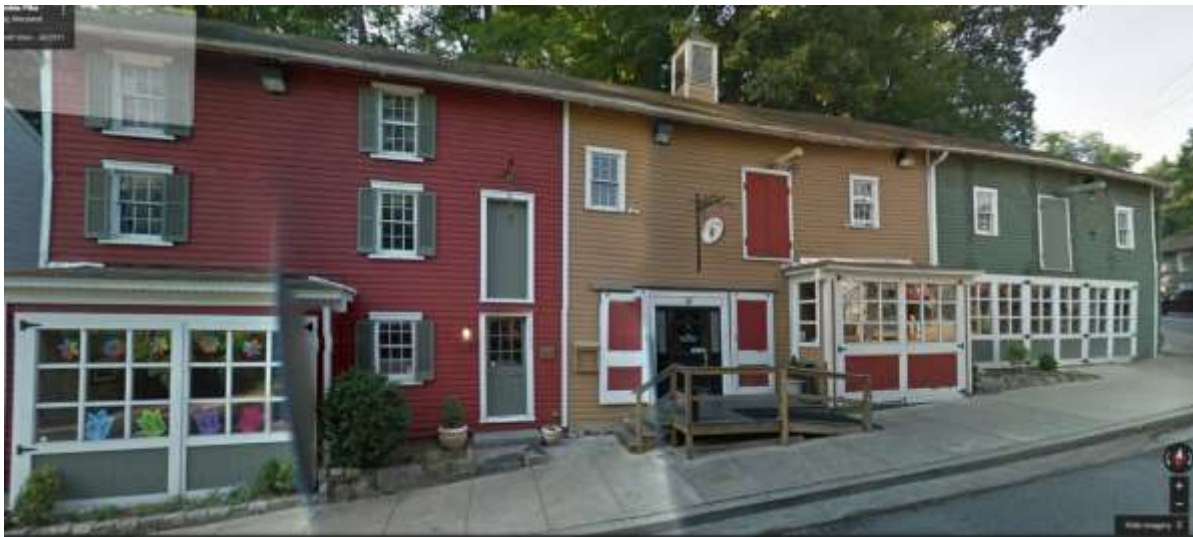
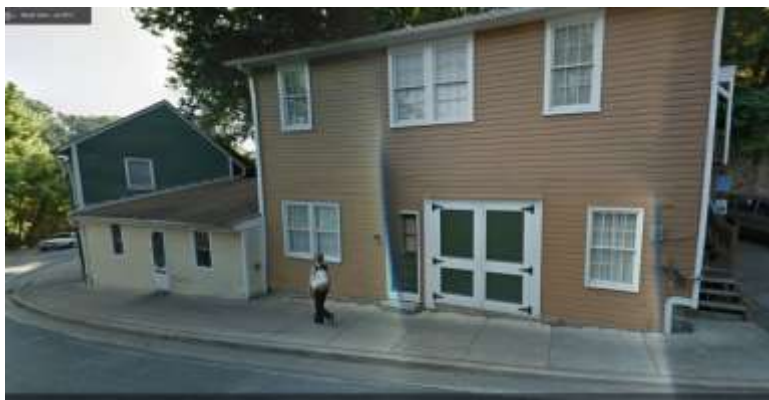
Figure 4 - Buildings along Old Columbia Pike

Figure 5 - Buildings along Old Columbia Pike

The building that is currently red will be painted with Benjamin Moore PM-16 Country Redwood and the current green shutters and doors will be painted PM-12 Black Forest Green. The mustard color building at the main entrance will be painted PM-12 Black Forest Green. The black doors and red inserts on the mustard building will be painted PM-16 Country Redwood. The brown building at the end will be painted HC-71 Hasbrouck Brown. The carriage door inserts will be painted 2159-40 Amber Waves. The green and yellow building will be painted 2159-40 Amber Waves. All trim will remain white.

The Applicant proposes to replace all double hung windows on the front and sides of the building, per the itemized photograph that was provided. There are 17 six over six double hung wood windows and 3 eight over 8 wood windows. There is one opening, labeled #17, that is currently a vent and the Applicant proposes to install a six over six window in this space.

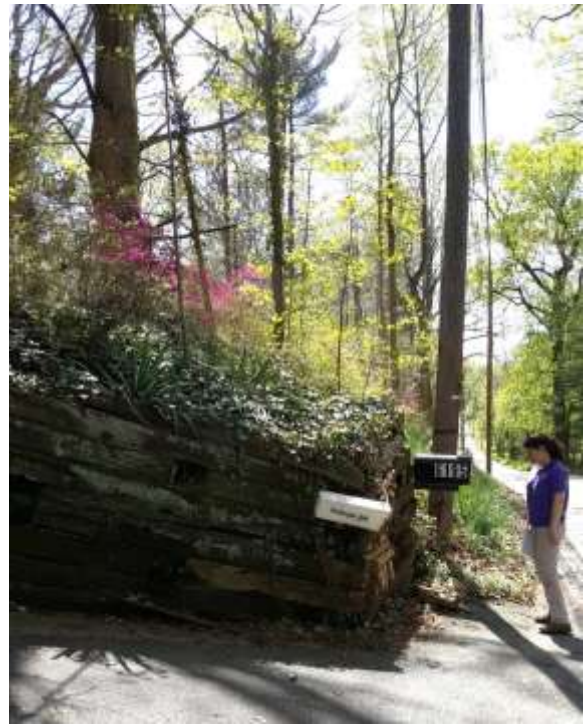
Figure 7 - Height of wall at street

- 1) Remove railroad tie retaining walls at the entrance to the driveway.
- 2) Build new Belgard Belair segmental retaining wall system in the color Sable Blend, which is a dark gray color. The segmental retaining wall system is made of precast concrete block.
 - a. The front section of the new retaining walls that run parallel to Lawyers Hill Road will be repositioned so that they are set back about 6 to 10 feet from the road to improve the line of sight for vehicles exiting the driveway.
- 3) Remove three trees on the east side of the driveway in order to build segmental retaining wall.
- 4) Install low voltage lights under the capstone of each wall and along the driveway on trees.
- 5) Install a low voltage transformer on the east corner of the house and bury low voltage power cable from the house to the low voltage lights.

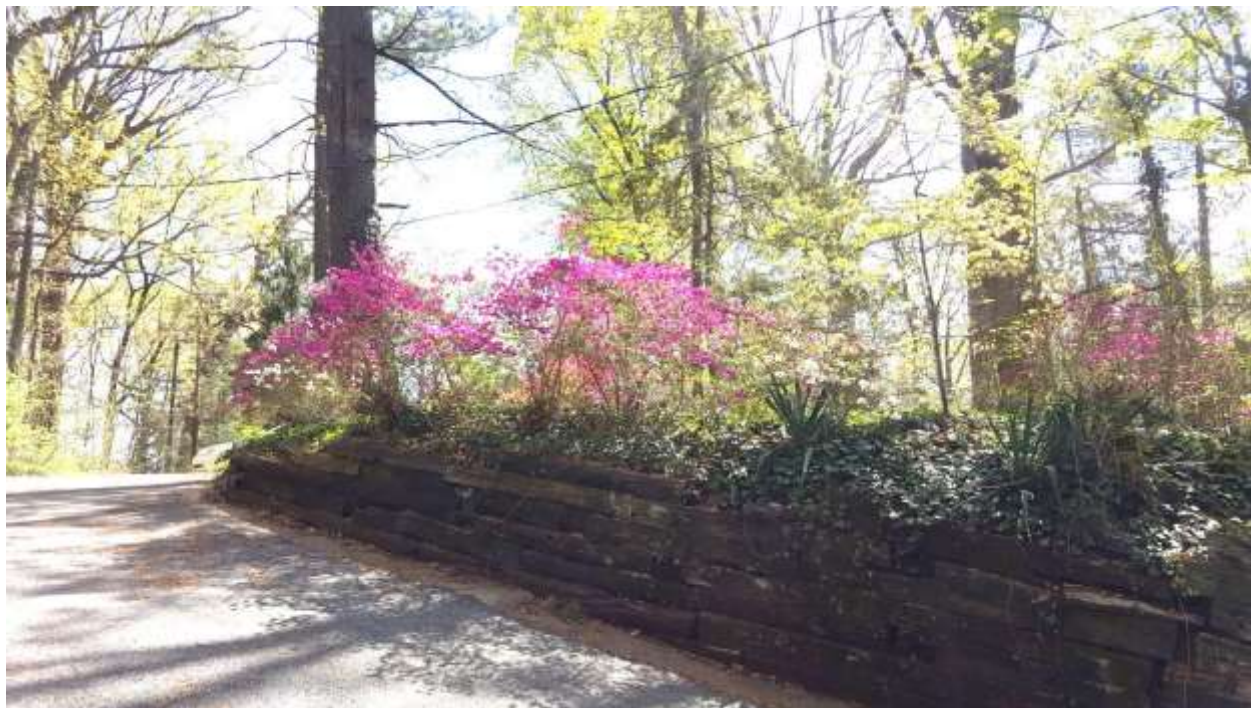
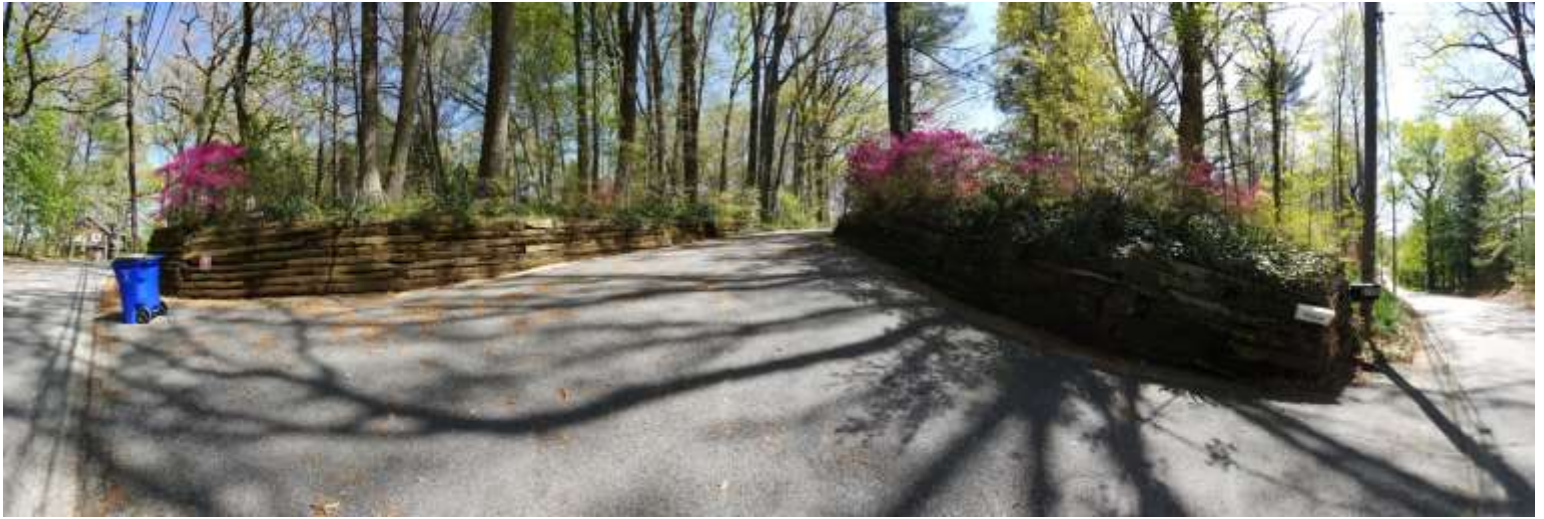
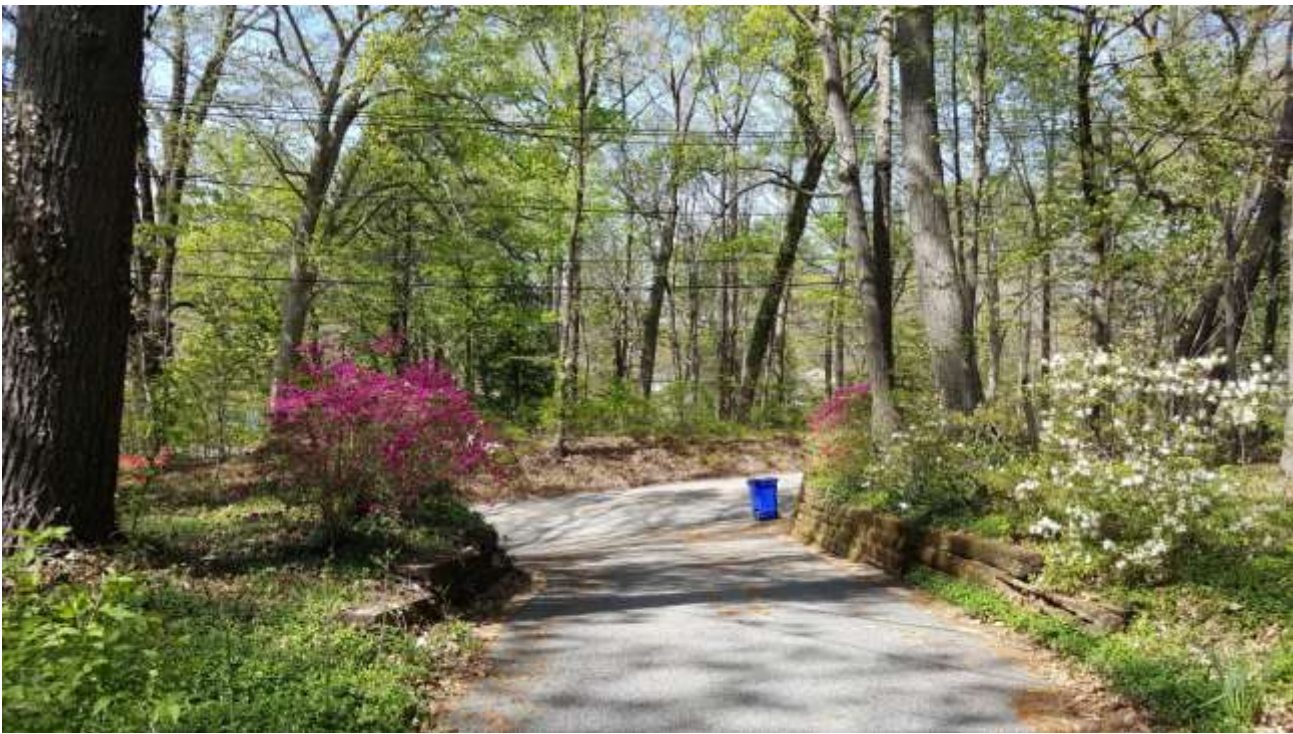
Figure 8 – Existing driveway

Figure 9 - Panorama of driveway

Figure 10 - Existing driveway

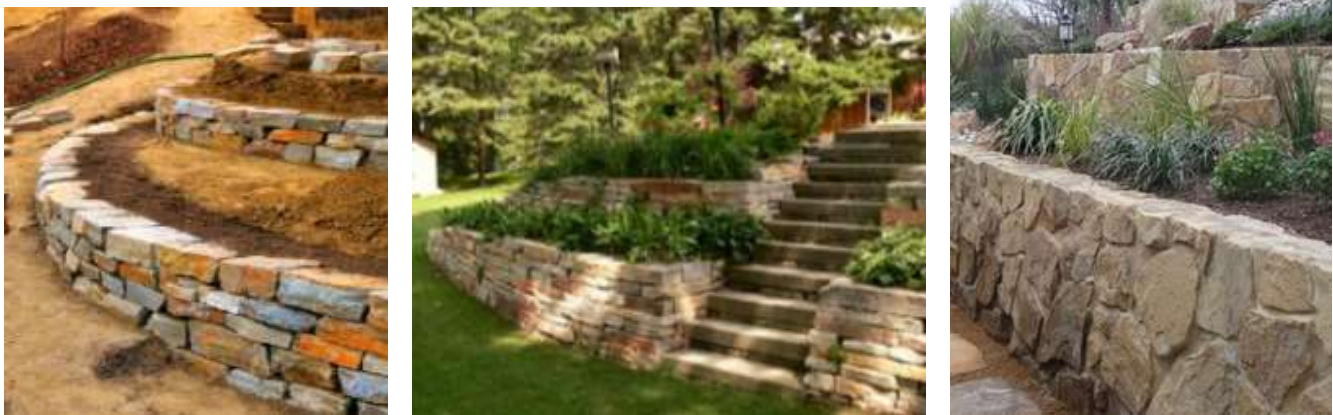
Figure 11 - Examples of terraced retaining walls

Updated Comments: The Applicant has been researching other options and Staff is interested to hear if any options have been determined to be feasible. Staff again suggests looking into terraced walls. Land will need to be removed when the walls are moved away from the street and instead of building a 6 foot tall wall, the wall could be terraced back away from the street (not terraced into the neighboring property). This would result in reducing a large expanse of masonry, as recommended by the Guidelines. Some examples are shown below:

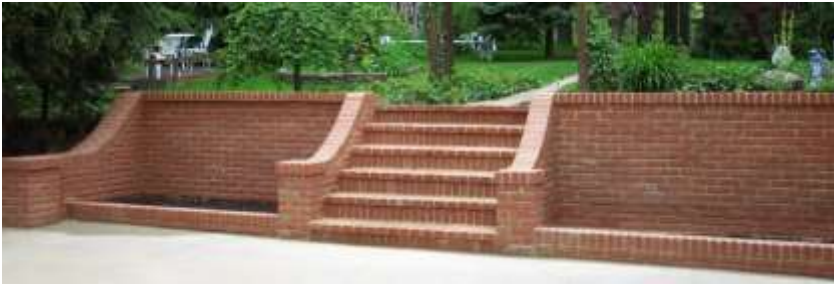
Figure 12 - Examples of brick walls

The Guidelines also recommend retaining walls faced with brick. Another suggestion would be to build a concrete or concrete block wall as mentioned above, and face it with brick instead of stone. Some ideas are shown below. While the images are not site specific, they do give an idea of the material used in a wall setting.

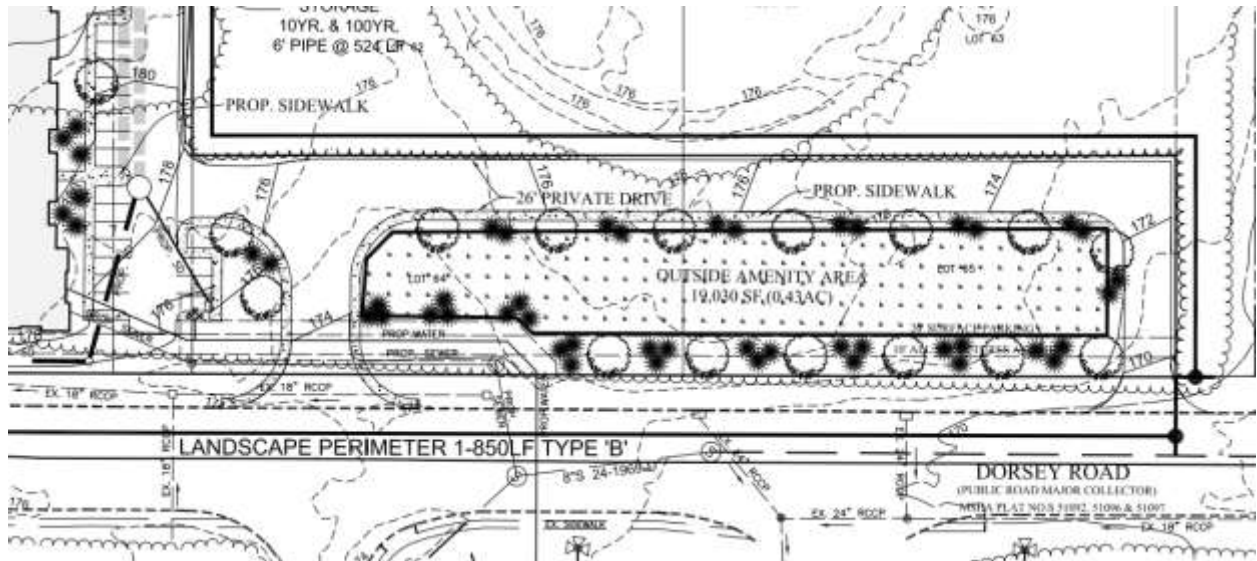
Figure 14 - Amenity Area site plan

Background & Scope of Work: This property is listed on the Historic Sites Inventory as HO-829, Rosa Bonheur Memorial Park. This project is before the Commission for Advisory Comments for the grading and construction of the main entrance drive to the adjacent development and the open space amenity area. The amenity area will include a covered open shade structure and benches, which will be located in the wooded section along Dorsey Road.

There are multiple parcels within this development, but the only land from the cemetery that is part of the development is the amenity area consisting of Lots 64 and 65, bordering Dorsey Road (shown in red below). The 7.27 acre remainder of Rosa Bonheur Memorial Park is not part of the development. The proposed amenity area consists of 1.28 acres of the 8.55 acre cemetery parcel.

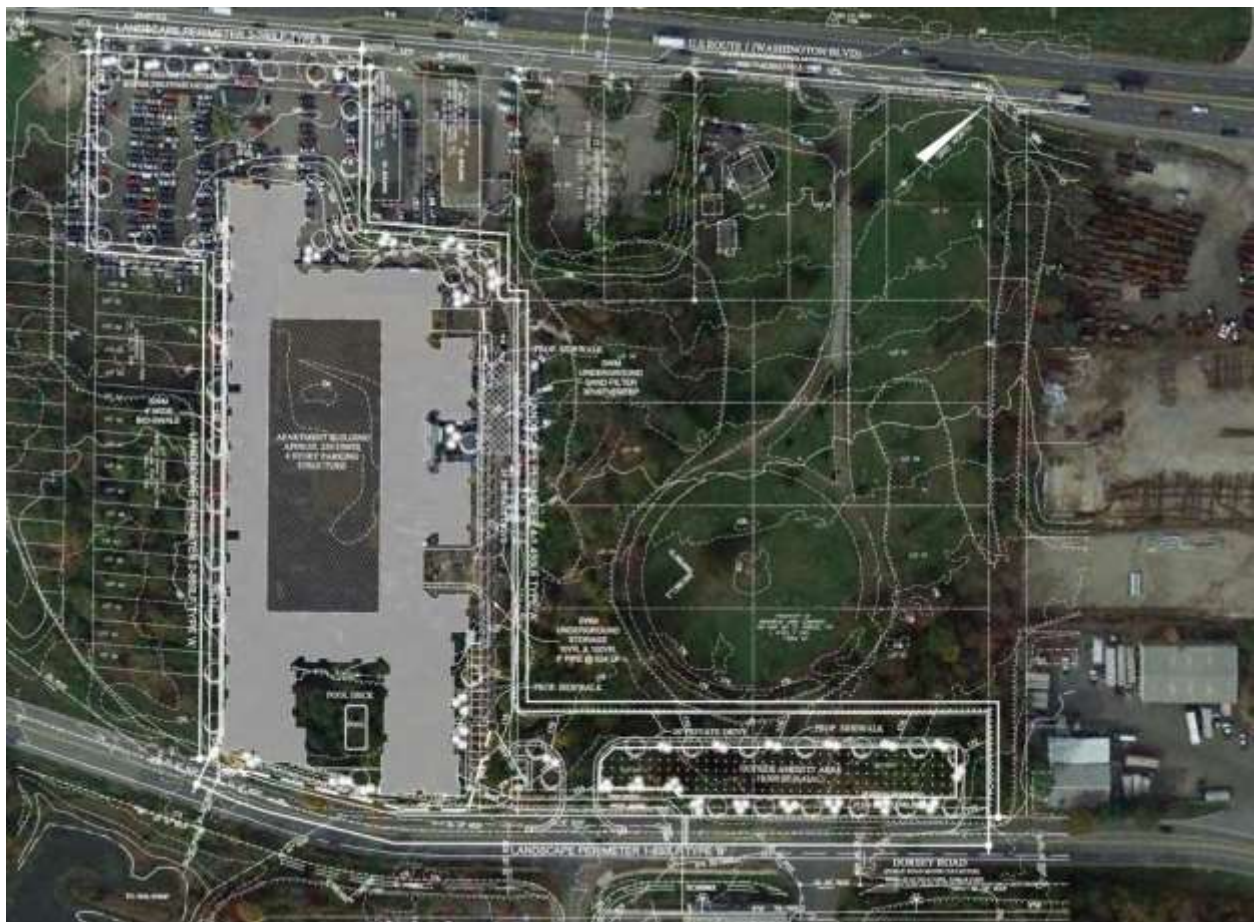
Figure 15 - Corridor Square site plan

The wooded area behind Rosa Bonheur, along Dorsey Road, will also serve as the main entrance into the apartment complex. The apartment complex will be on the neighboring site to the left of Rosa Bonheur, as shown in the site plan below.

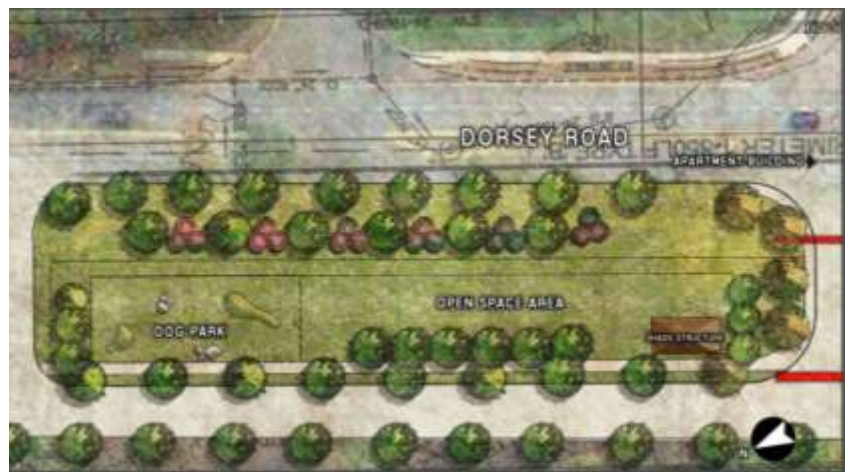
Figure 17 - Amenity space rendering

There is a sidewalk shown on part of the amenity area, but it does not continue around the whole area. Staff recommends the sidewalk be continued to create an entire loop for pedestrian use, as this is a proposed amenity area. Pedestrian access and crosswalks should be provided across the new road to guide visitors into the cemetery.

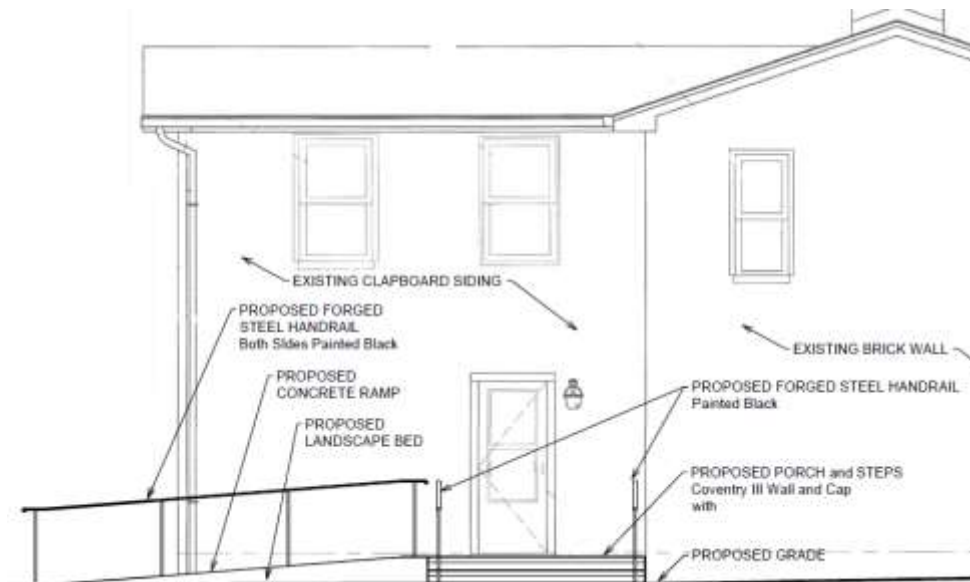
Figure 19 - Proposed alterations

The ramp will be added on the rear of the brick structure, adjacent to the side of the frame addition. The ramp will be constructed out of concrete and have a forged steel handrail painted black. There will also be a porch/landing area and steps leading off of the side door, next to the ramp, leading to a paved patio. The porch and steps will be constructed with EP Henry Coventry block concrete pavers in the color 'Dakota Blend.' The patio and tent paving material will be Nicolock Pavers in the color 'Oyster Blend.'

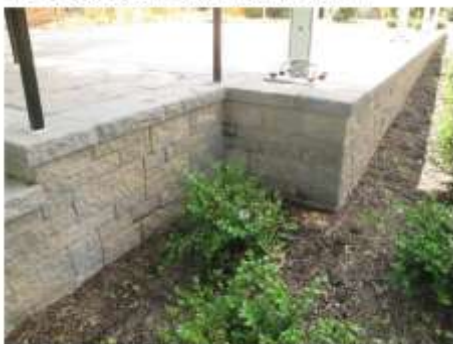
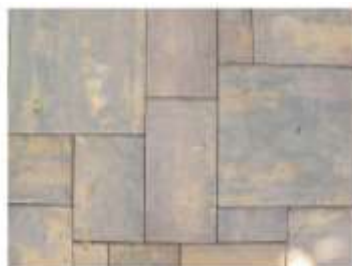
Figure 21 - Pavers for patio and tent

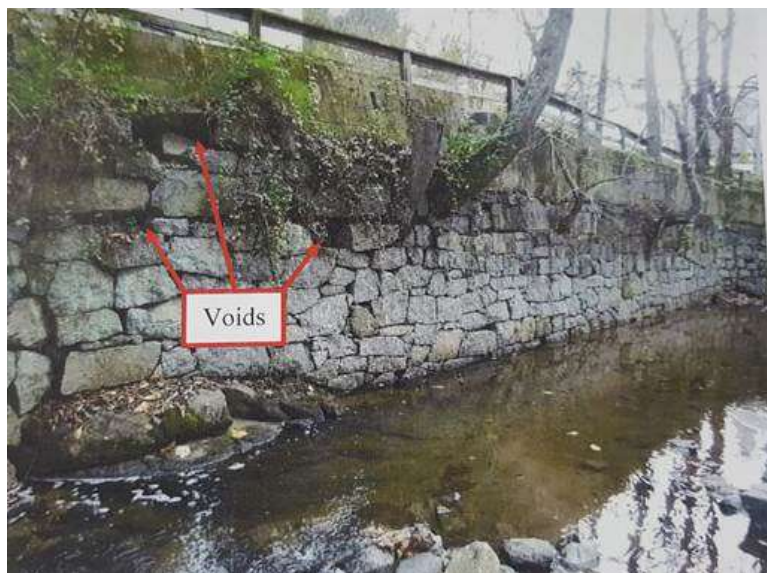
Figure 22 - Retaining wall 8A to be replaced

Background & Scope of Work: The retaining walls are located in the Ellicott City Historic District between Parking Lot E and F and are historic, granite walls dating back to the origins of the town. The retaining walls are in poor condition and are failing. Howard County has conducted an inspection and inventory of the retaining walls along the Hudson Branch in Ellicott City. The application explains that, “As part of that inspection, several retaining walls were identified as needing varying degrees of maintenance from vegetation removal to full replacement. The walls between Parking Lots E and F were among those walls identified as requiring repair and quickly became a priority, specifically wall 9A...It was identified as being in serious condition with failing joints, bulging, loose and missing stones and most noticeably it is leaning toward the stream.” The application states that walls 9A and 8A will likely be replaced with reinforced concrete cantilevered retaining walls. There will be a stone veneer on the walls, similar to the walls found at Parking Lot E.

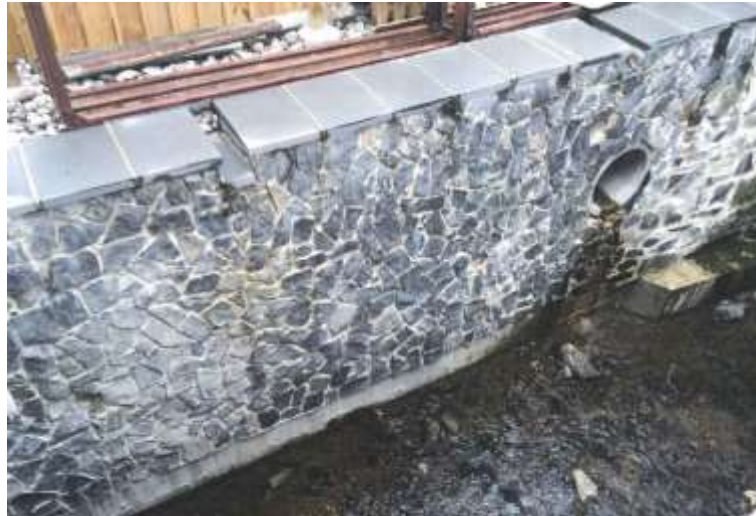
Figure 22 - Proposed replacement wall. Above wall located in Parking Lot E

Staff Comments: Chapter 9.D states, “Granite features, especially those visible from public ways, should be preserved with the same attention given to historic buildings. They provide a strong link not only to the town’s past, but also to its unique topography.” The Guidelines go on to say, “retaining walls of granite, brick or timber may be appropriate, depending on the context. Concrete walls can be used in locations with very little visibility. New granite walls are expensive, but retaining walls faced with granite or with a surface treatment that resembles Ellicott City’s typical stonework can be appropriate in visible locations.” The proposed reinforced concrete cantilevered walls will be faced with stone, similar to the wall in Parking Lot E. The use of the stone veneer complies with the Guidelines, as the concrete is needed to safely rebuild the wall. However, Staff is concerned about the visual appearance of the proposed random pattern stone veneer next to the historic stacked granite block wall. The treatment to Parking Lot B after the train derailment is an example of mixing a historic wall with a modern wall (originally the new wall in Parking Lot B was going to be larger and less of the historic wall was going to be visible). This wall turned out different than originally proposed as more of the original wall remains visible, as shown below, and the end result is a mixture that needs to be avoided in the future. The example of the veneer in Parking Lot E is a good color of stone to use though, as it is compatible with Ellicott City granite, but the pattern is too random.

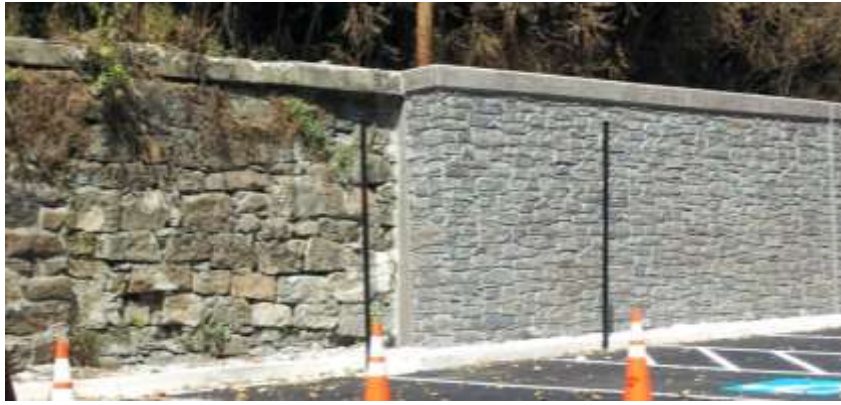
Figure 23 - Replacement wall next to historic wall at Parking Lot B

Over the past several years Ellicott City has dealt with several failing walls and each wall has been repaired or rebuilt differently. It is a unique situation that the town is in, as granite walls are a prominent feature for retaining land, houses and the rivers. As these walls fail and are rebuilt, the designs need to not only be consistent, but aesthetically pleasing. The Guidelines explain, “the Ellicott brothers brought workers, including stone cutters, with them when they settled and built. Stone quarries were established on both sides of the Patapsco River and continued to operate into the 1870s, with two quarries and two granite cutters listed in the 1878 Hopkins’ Atlas. The first Ellicott’s Mills buildings were wood, but many early buildings were granite. This early granite construction, combined with the area’s natural rock outcropping and steep terrain, established patterns of construction and land development that remain today as important elements of the town’s environment.” To date, there has not been a repair or replacement project completed that can be identified as the one solution for Ellicott City’s wall problem. As this project has the potential to be quite large, Staff wants to make sure the replacement material is the most appropriate. While the proposed stone would be fine for a new wall, Staff finds it does not look appropriate next to the large historic block walls and draws more attention to the repair as the contrast between the new all and historic granite is quite obvious. In areas where the wall will be replaced in entirety, Staff finds the proposed replacement will match the treatment that was done in Parking Lot E. However, that again creates a variety of wall types around town. In areas where historic stone block will remain and only small sections of replacement will take place, it may be more appropriate to have a different type of veneer. While brick would not have been used to construct a river bed, concrete can be stamped and stained to look like brick and that could be an option for the facing of the wall next to a historic stone.

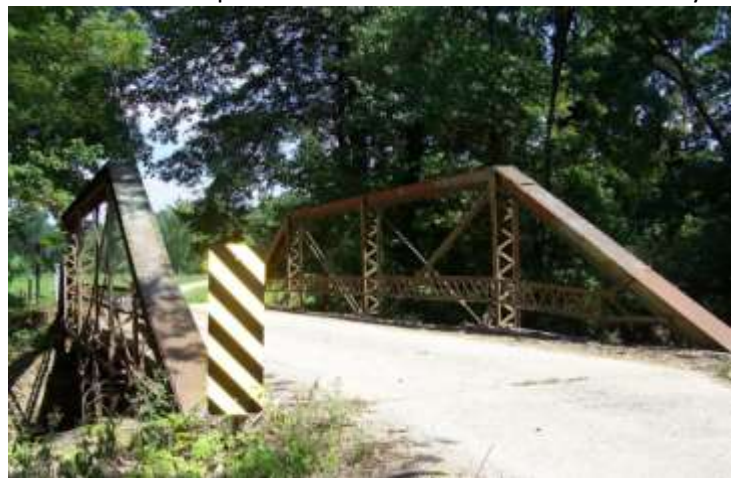
Figure 24 - Hubbel Station Bridge in original location

The proposed bridge to be used is a Pratt Pony Truss Bridge called the Hubbel Station Bridge from Indiana. The bridge is a historic bridge dating to 1905. The truss bridge is similar in design to other bridges found around Ellicott City. The application explains, "The bridge placement is designed to utilize the existing apron and driveway for minimal environmental impact and not to obstruct current visibility of the home." The bridge will be located at the lowest elevation allowed per the Howard County Flood Plain Code Guidelines. There will be no removal or changes to any of the existing structures. The bridge is 60 feet in length and 14.1 feet wide and 9 feet in height at tallest point. The bridge weighs 14 tons. The Applicant would like to install the bridge in its current state, which is a natural rusted patina with bits of green paint remaining. However, the Applicant is also open to painting the bridge black if desired by the Commission.

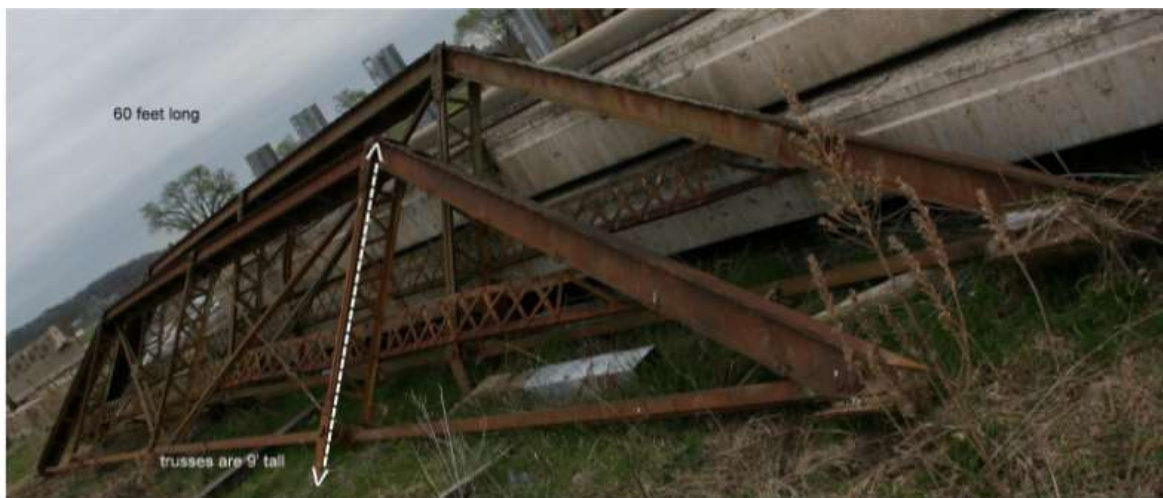
Figure 25 - Natural color of bridge

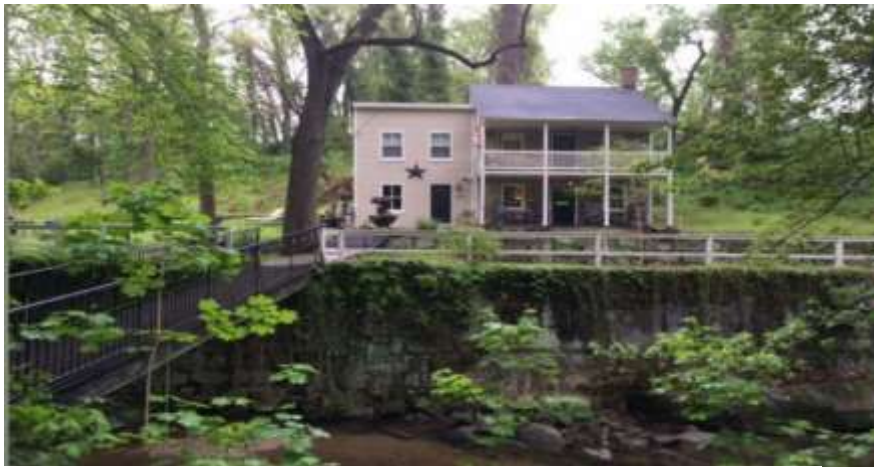
Figure 27 - View of house from driveway

Bridge abutments will need to be constructed to support the bridge. The abutments will be poured concrete, with a textured stone pattern to simulate the existing stone wall. The concrete will be tinted gray. The abutments will be below Frederick Road, nestled into the hill. As shown in the photo above, the area will not be visible from the road and will be minimally visible from the house. A black metal railing will be built to match the pattern found on the vehicular bridge. The railing will be located on the stream side of the driveway.

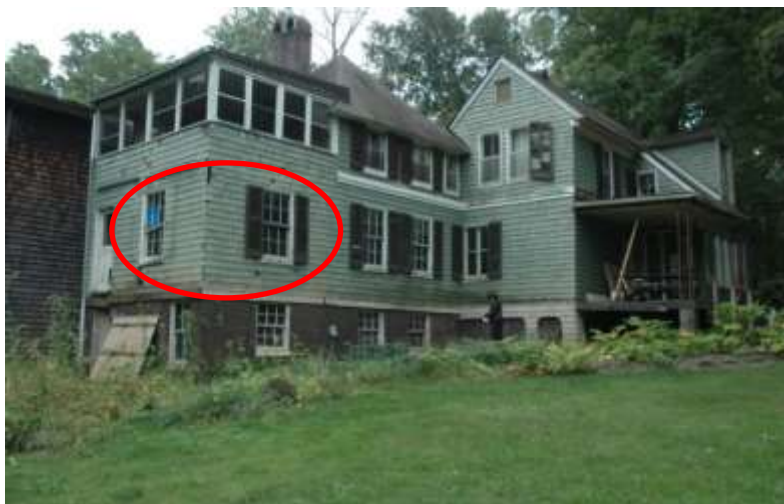
Figure 28 - Side and rear windows to be shortened

The repair and painting of the existing windows is Routine Maintenance and eligible for tax credits per Section 20.112 of the County Code. Chapter 6.I of the Guidelines explains, “window arrangement, size and shape are important in establishing the proportion, scale and character of a building. The materials and details of window frames, sashes and trim also contribute to the building’s character and should be preserved whenever possible.” The proposal to change the size of the two window openings on the side and rear of the structure do not comply with Chapter 6.I recommendations, “maintain existing window openings.” The Guidelines do go on to say, “If openings must be removed, added or altered to accommodate changes such as enlargement of the building, limit such changes to the sides and back of buildings (not on primary facades or facades visible from a public road). The rear window is not visible from the road. There is a repetition of size with the first floor side windows, which together are a defining side of the building. Staff finds this side window should remain the same size, but that the rear window is less visible, not part of the row of windows on the side and that alteration of that window would not be as destructive to the integrity of the property.

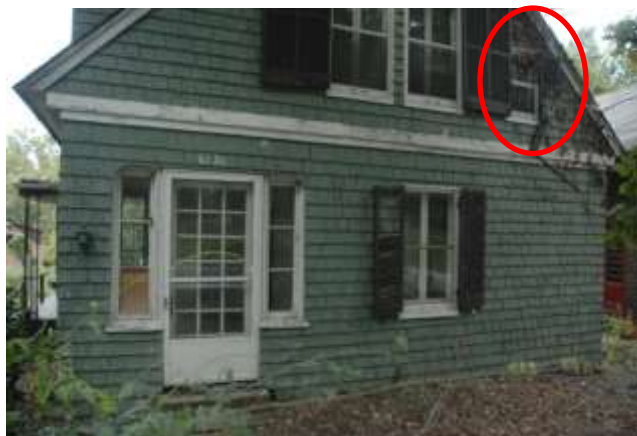
Figure 29- Front window on house proposed to be removed

Likewise, the proposed removal of the small window on the front of the building (south side) does not comply with the Guidelines mentioned above. The building is a Shingle Style building; hallmarks of this style include asymmetrical facades.

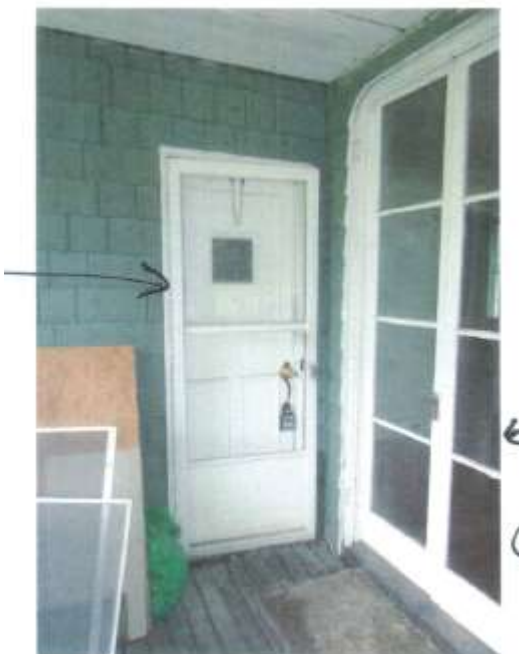
Figure 30 - Door #3 to be removed and void covered with shingles

The Applicant proposes to remove door #3, which is the current main entrance into the home. The space would be shingled over. The Applicant then proposes to remove the French doors, labeled door #2, and replace them with a 6-lite over 2-panel Craftsman style door to be 36 inches wide by 80 inches tall. The French doors are shown below from the interior of the home. That space of the house serves as a sunroom. The Applicant wants to replace the French doors with the Craftsman style door to make it more secure. The opening for the French doors is approximately 40 inches wide by 90 inches tall, which is larger than the proposed door. The opening would need to be framed out to be smaller in order to accommodate a door. This proposal does not comply with the Guidelines. Chapter 6.K recommends, “maintain and repair original doors, door frames, sidelights and transoms; weatherstrip doors to reduce air infiltration.” The Guidelines recommend against, “unnecessarily replacing original doors” and “changing the size of door openings; blocking or filling doors openings, transoms or sidelights.” Staff finds the Craftsman style door is also not an appropriate style given the style of the 21-lite front door shown below, and the 3 lite windows throughout the room. The French doors are a character defining element of the house and their removal would ruin the integrity of the building. Staff suggests the Applicant install an interior door in the opening leading into the house if security is desired (the opening as shown in Figure 32 on the right of the picture).

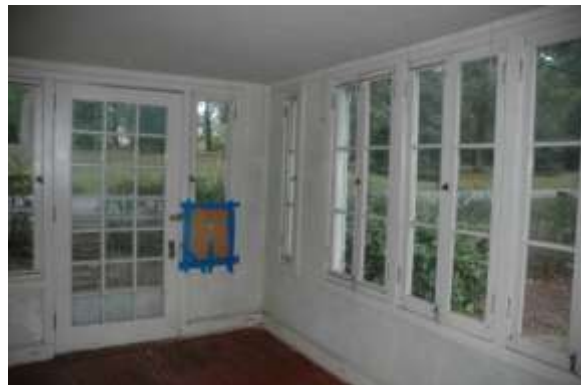
Figure 31 - Door #1 to be repaired on sunroom. Door #2 to be removed is opposite this door.

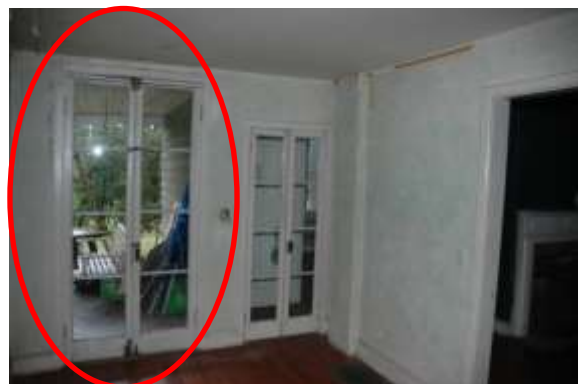
Figure 32 - French doors proposed to be removed as seen from inside

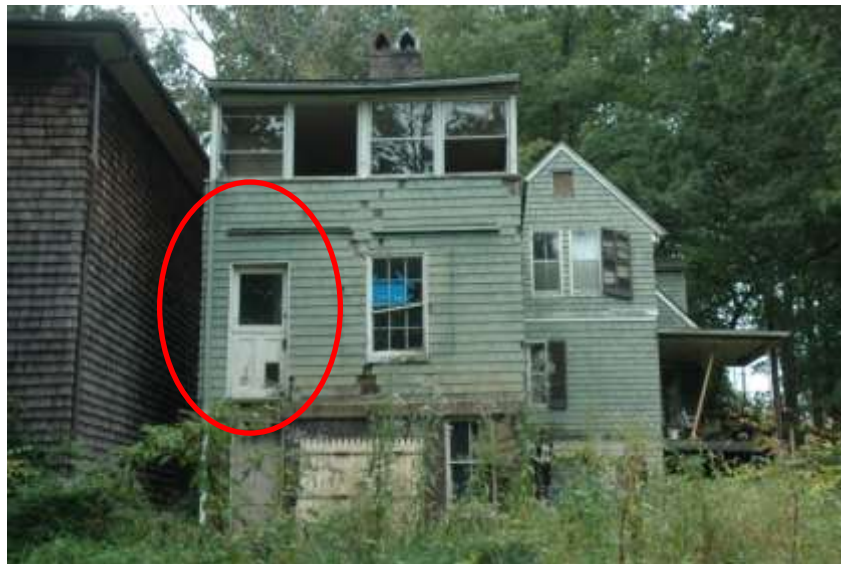
Figure 33- Rear door to be replaced

There is a 1 lite over 2 panel Dutch door leading out of the kitchen on the rear of the house. This door used to lead onto a porch. The Applicant proposes to remove the Dutch door (incorrectly labeled door #4 in the photos – this is actually door #5) and replace it with a 6 lite over 2 panel wood door. The Dutch door has been altered over time, as a pet door has been installed in one of the panels. However, the bottom portion of the door could be rebuilt and the top portion remain, which would qualify for tax credit pre-approval. The Guidelines recommend, “when necessary, install replacement doors that are similar in style and finish to the original doors or appropriate to the style of the house.” The entire replacement of the Dutch door does not appear to be necessary. However, if it is determined to be necessary, Staff recommends the Applicant install a 1-lite over 2-panel door to mimic the existing door. Staff recommends tax credit pre-approval for a new door only if it is determined to be necessary. The Dutch door is a unique feature and should be preserved if possible. The windows above the Dutch door in the rear enclosed porch were also not addressed in the application. Staff requires additional information on the material of those windows (which Staff believes are vinyl) and what the replacement will be.

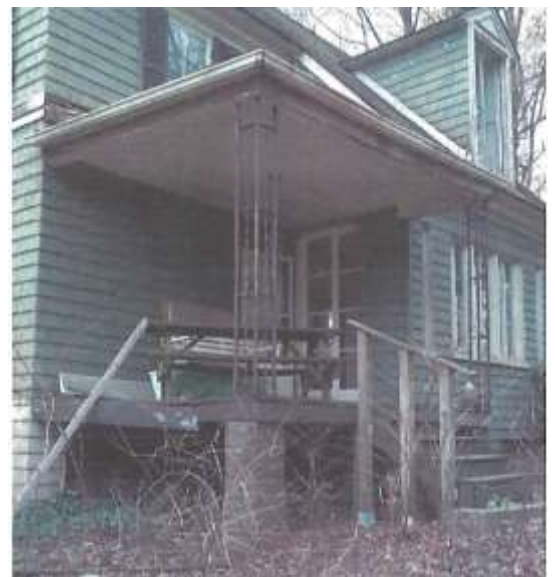
Figure 34 - Side porch to be replaced

The side porch will be rebuilt. The application explains that the existing porch will need to be removed and then rebuilt. Google maps shows that in 2012 there was an open air deck that extended around the house, so the porch in its entirety has already been altered, most likely due to its poor condition. The rebuilding of the porch complies with Chapter 6.F recommendations, which recommends maintaining and repairing porches. In this instance the porch must be removed and rebuilt, as it was not properly maintained.

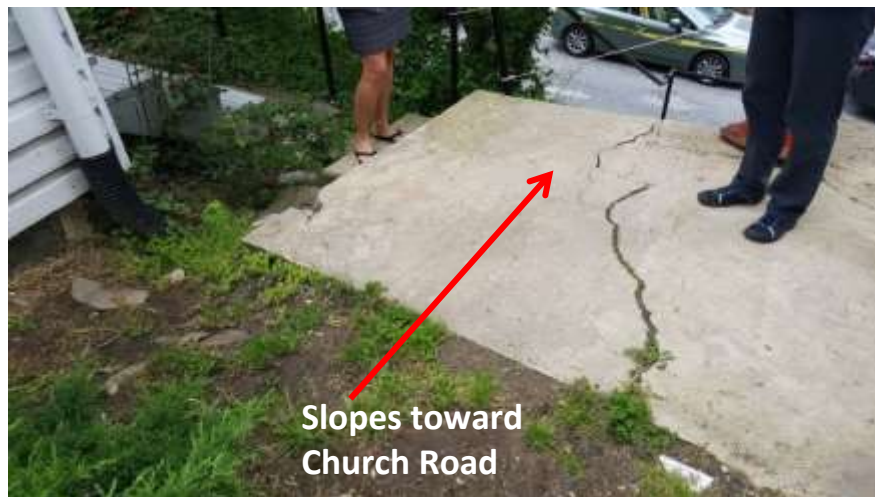
Figure 36 - Landing off of porch at the top of staircase to Church Road

- 1) A cement platform, connected to the front corner base of the building is showing major cracks throughout the platform and needs to be replaced. The platform is connected to the front corner base of the building which supports the front porch and entrance way to the building. It is unknown if the front base is a support for the porch or part of the building foundation.

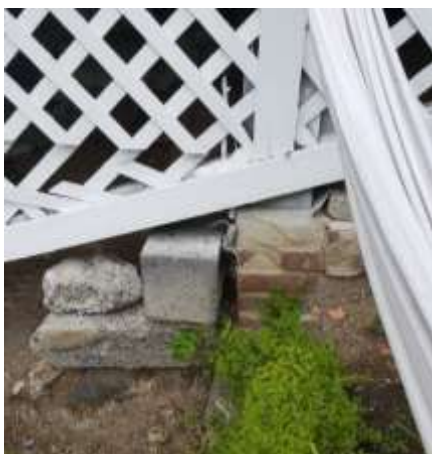
Figure 37 - Porch foundation piers

- 2) The corner support for the front porch, which is cinderblock and old stone, is cracked and breaking and has separated from the construction of the front porch of the building, and needs to be repaired. There are three other supports that have been fixed over the years using a variety of materials. All four supports will need to be examined for structural stability and possibly repaired.

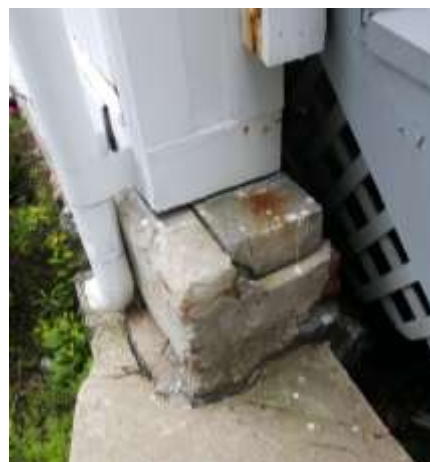
Figure 38 - Porch foundation

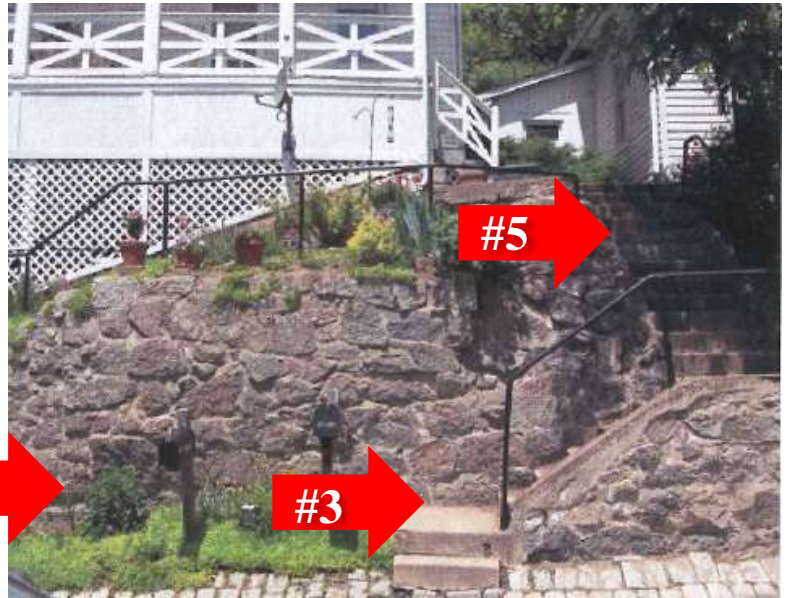
Figure 39 - Wall and staircase at Church Road

- 3) There is a stone wall parallel to Church Road where the first run of stairs is located between two landings. The stairs will need to be replaced and the wall will need to be repaired and repointed.
- 4) The large stone wall along Church Road has been deemed 'unsound' by the owner's USAA insurance. There is visible bulging and protruding stones.

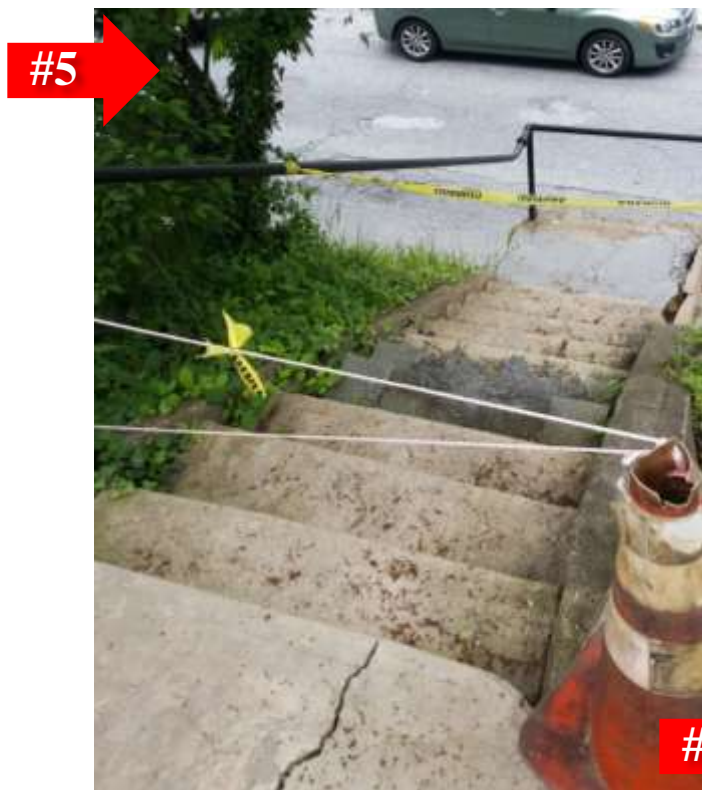
Figure 40 - Staircase down to Church Road

- 5) The second flight of stairs, running perpendicular to Church Road, have cracked and crumbled over the winter and needs to be replaced.
